CHARITY BUILDING, ORIHUELA

RESTAURATION

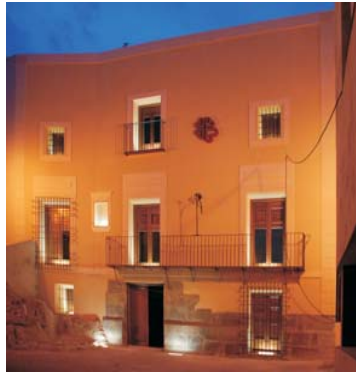
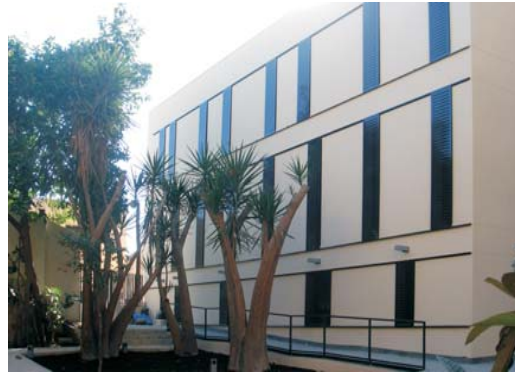
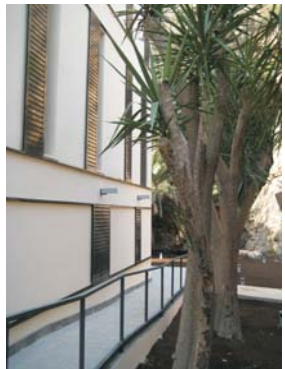
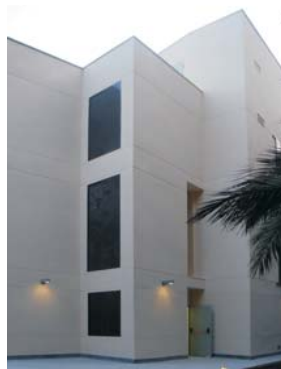
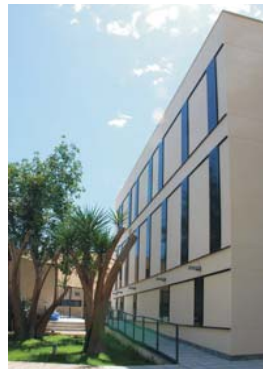
The action aims to recover a unique place in the layout of the city of Orihuela, taking into account the situation of the plot according to the Cerro de San Miguel.

It is also aimed to recover the building, very damaged, as far as possible, providing it new uses. The recovery of the building passes through the restoration of the existing areas and the reconstruction of the destroyed ones.

For the rehabilitation of the building, a circulation core is located at the rear part of the building, putting into value the privileged view of the rocky outcrop of the Cerro de San Miguel. On the ground floor are located the access to public areas such as workshops, meeting hall and shop. The upper floors will be used for residence. The first floor contains eight bedrooms and a small apartment.
